NL INDUSTRIES/TARACORP SUPERFUND SITE GROUP

**Re: NL Industries/Taracorp Superfund Site; Granite City, Illinois
Second 2017 Semi-Annual Operation and Maintenance Inspection (December 2017)**

**NL Industries/Taracorp Superfund Site
Inspection Log - Operation and Maintenance**

Inspection Date: 12/4/2017
Weather: Cloudy, windy, 55 F - 60 F

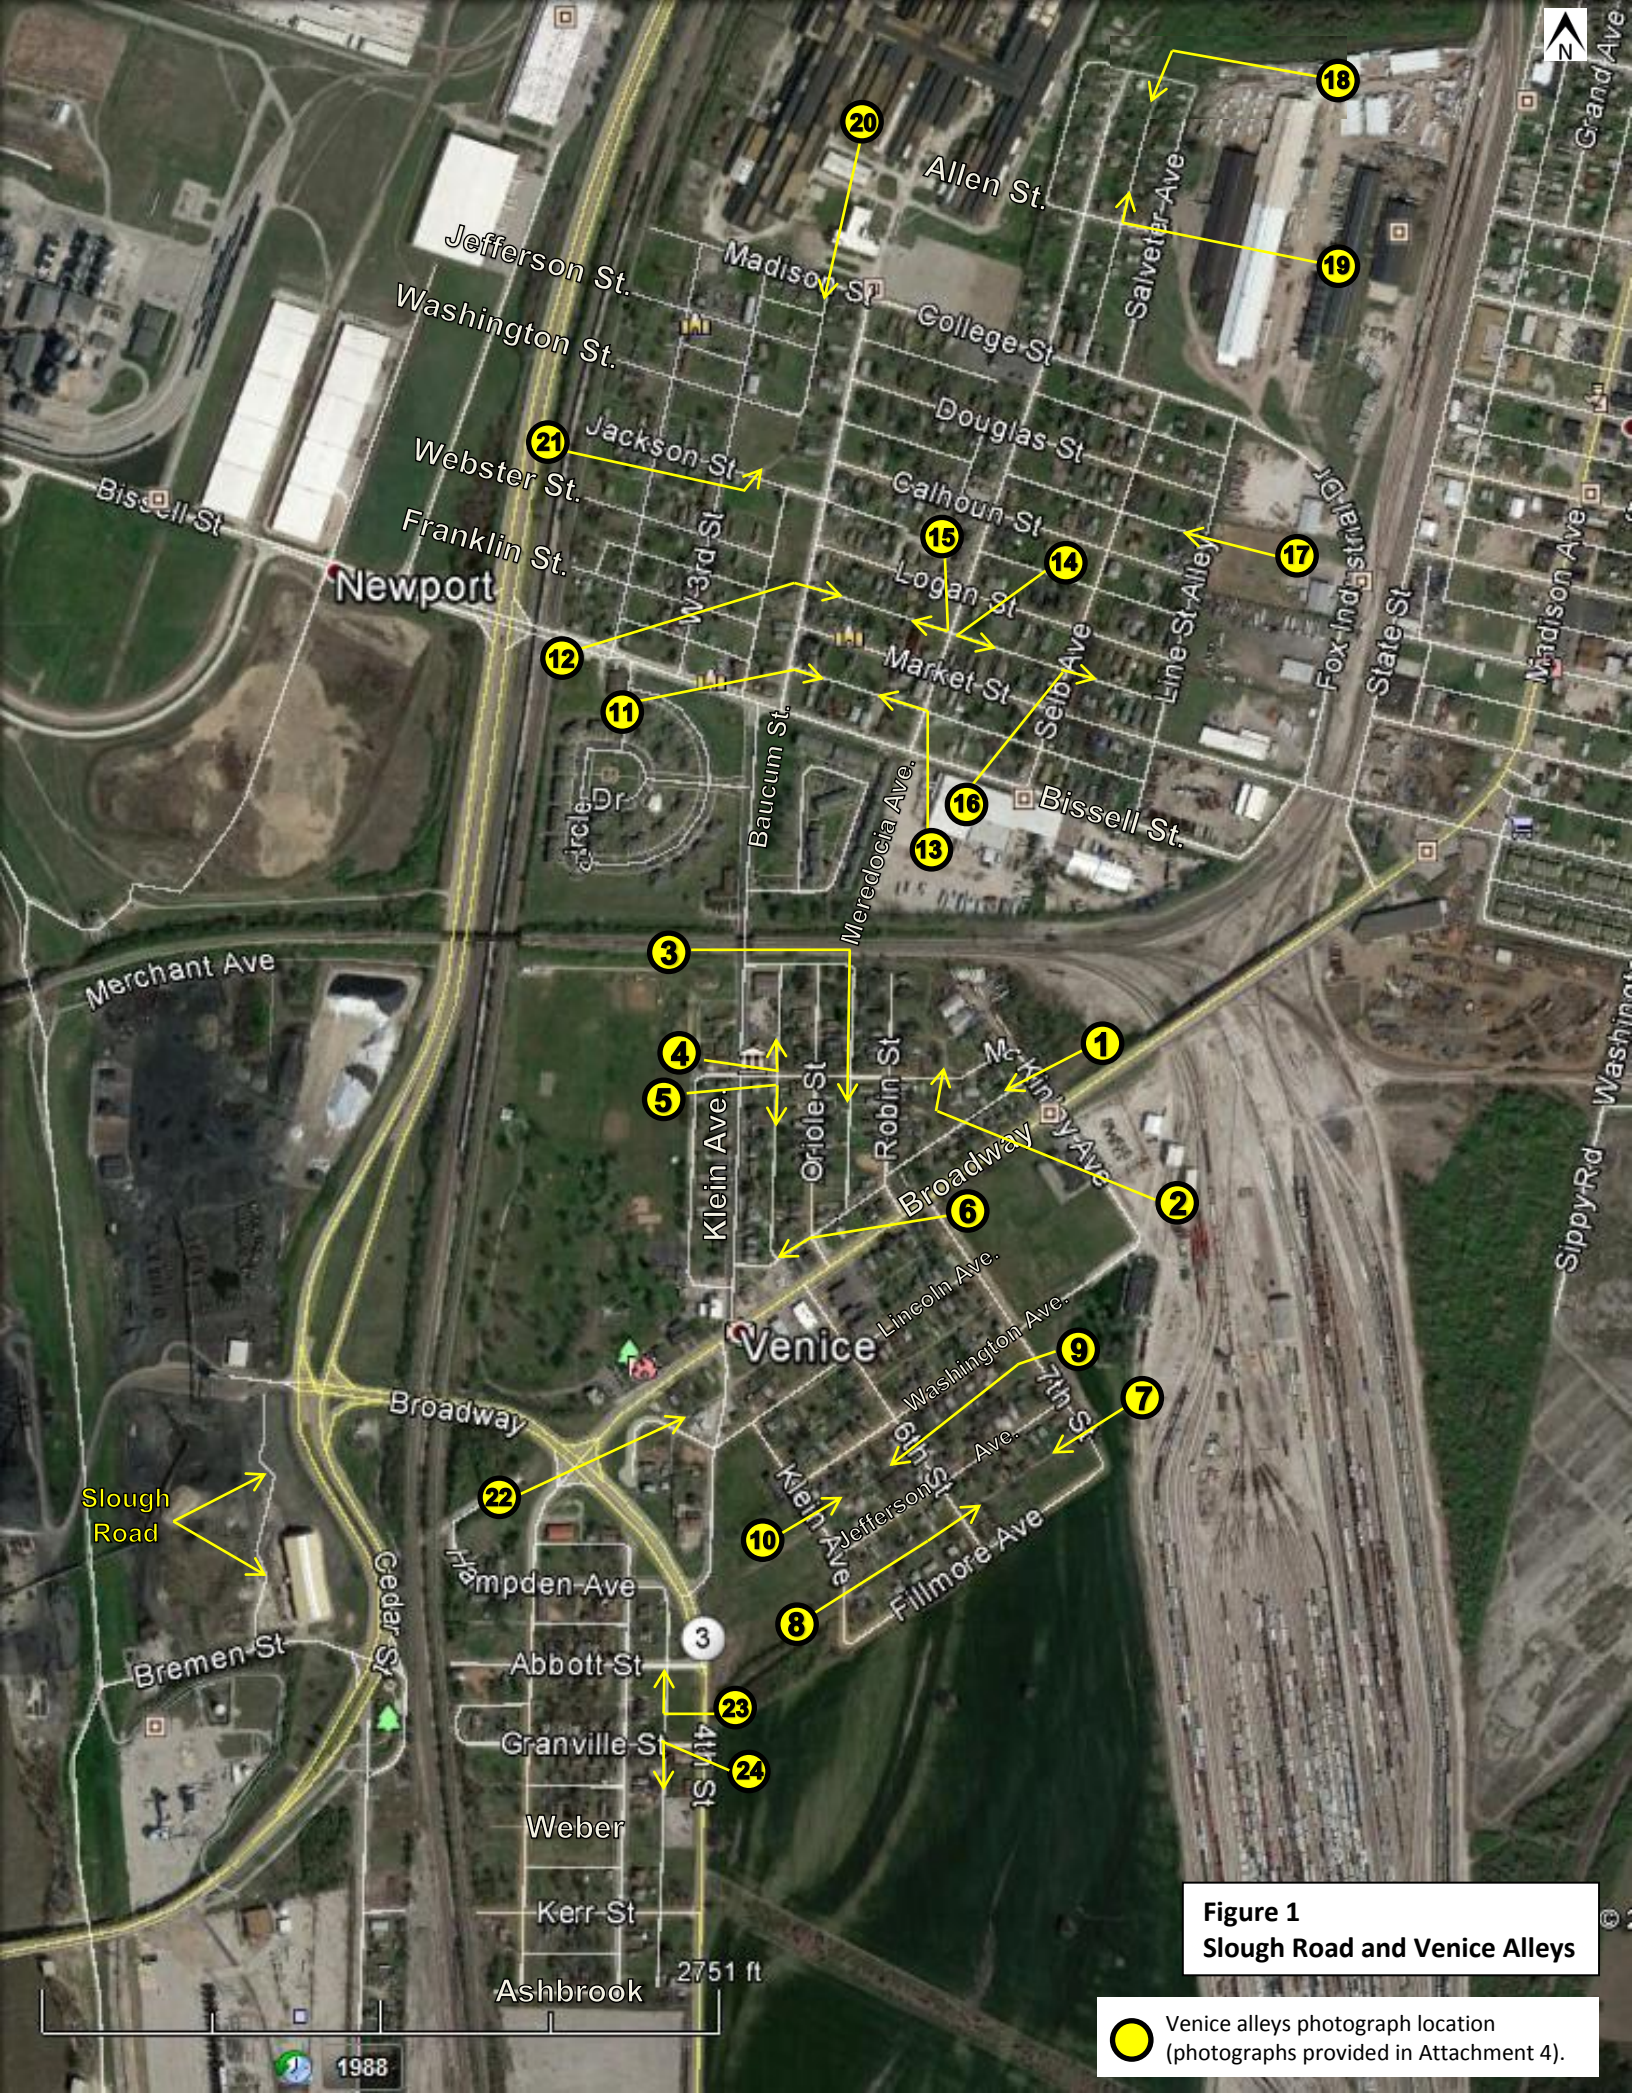
Figure 1
Slough Road and Venice Alleys

- At Slough Road (shown on Figure 1 and the photographs in Attachment 1), I met with Mr. Earl Boyd, Terminal Manager for Beelman River Terminals, Inc. (Beelman). Mr. Boyd confirmed that there has been no disturbance to the paved surface of Slough Road (which is no longer visible) since the time the paved roadway was covered with soil fill as part of the expansion of Beelman's operations.

- Alleys in Venice that were paved during remedial activities were inspected and noted to be in generally good condition, with some minor cracking and deterioration observed in some areas, with no battery case chips visible. The Venice alleys are shown on Figure 1 and are identified on the photographs in Attachment 4. Previous inspections have confirmed that the local municipality is continuing to repair and repave alleys, as necessary (Attachment 4, photograph 9).

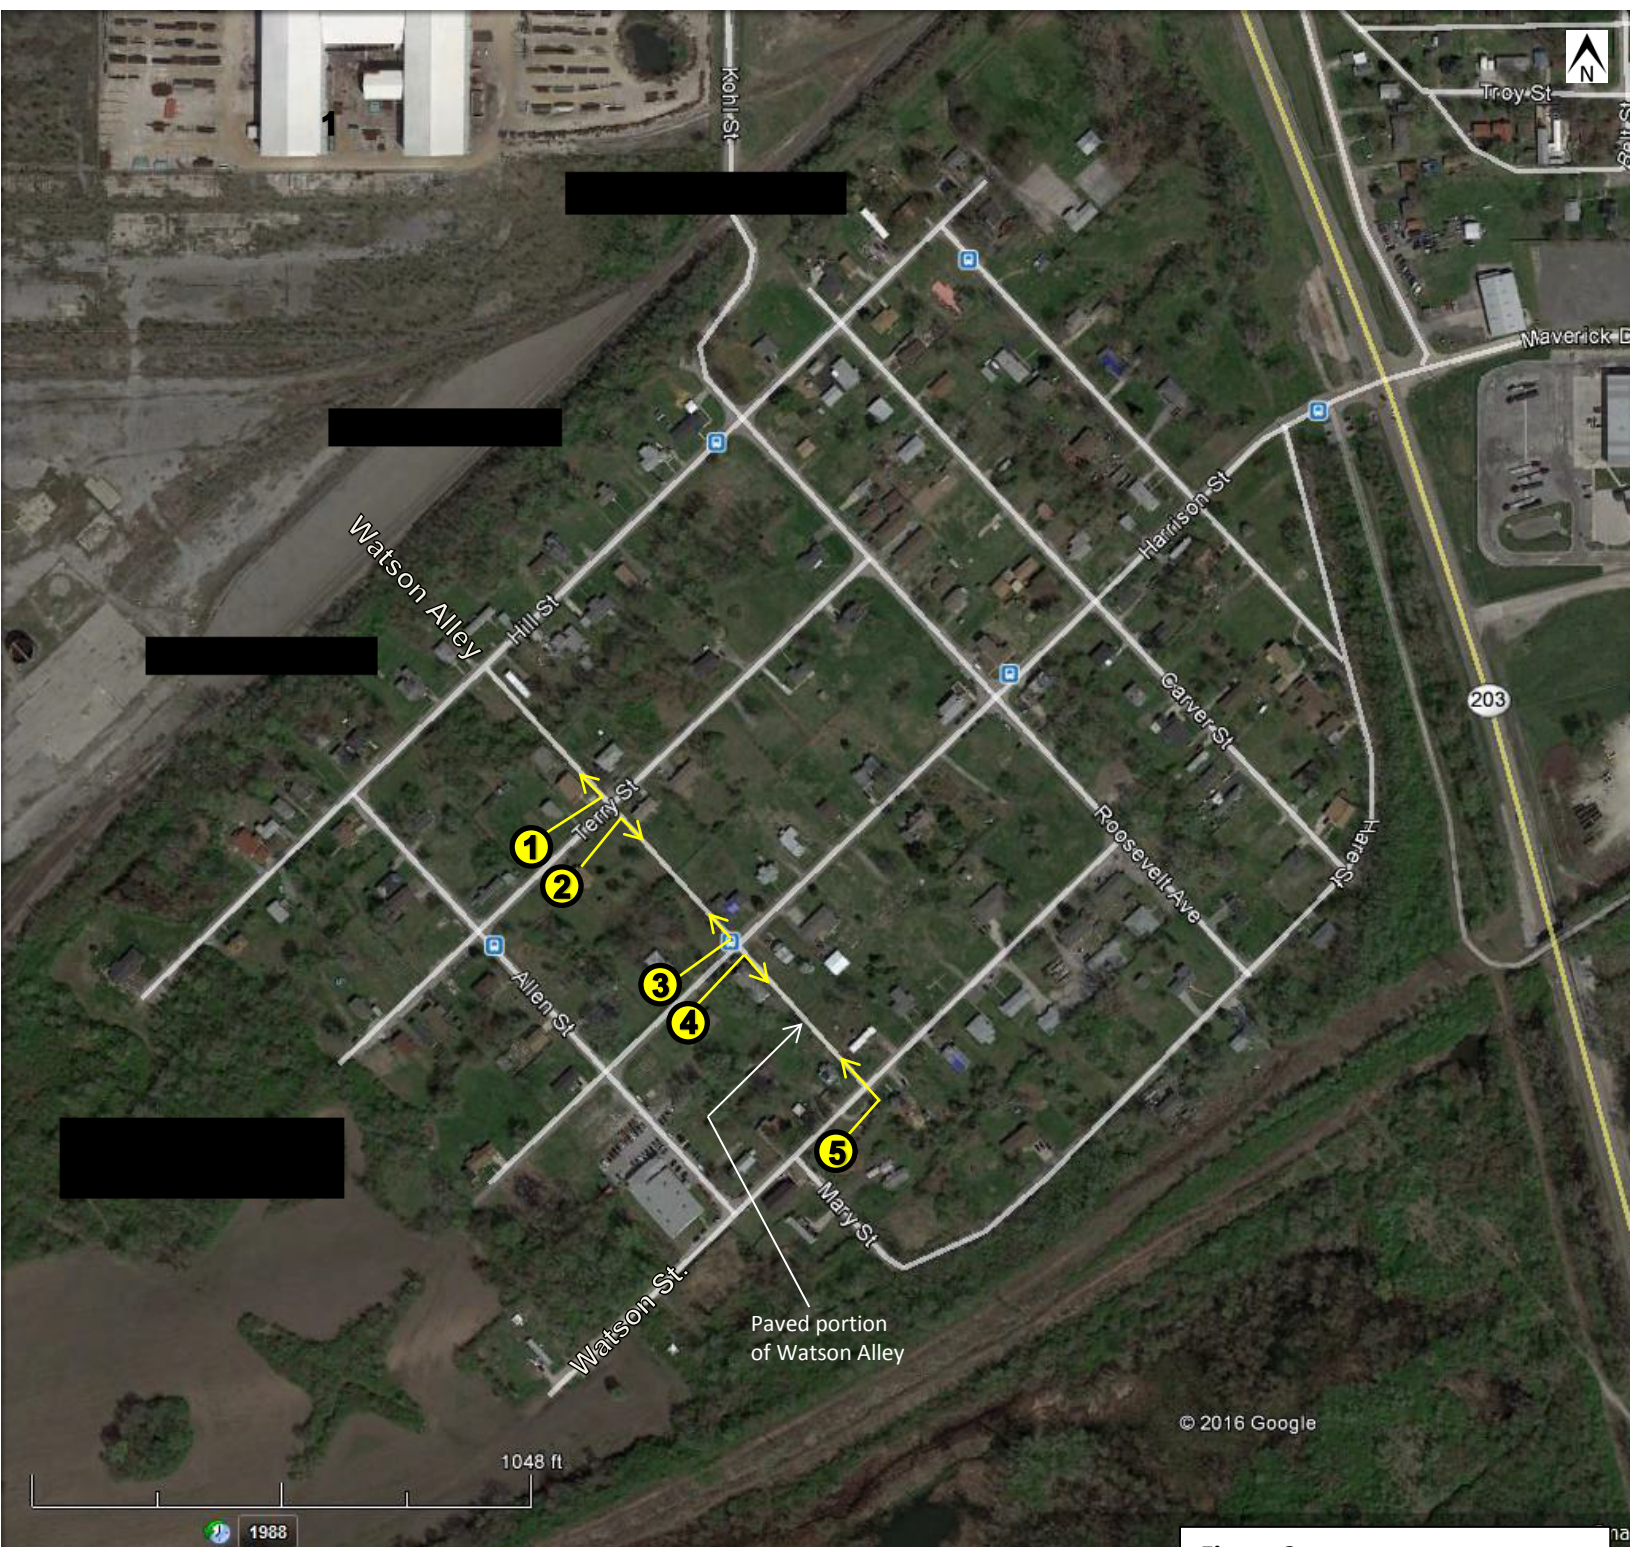
Figure 2
Eagle Park Acres – Watson Alley

- The paved portion of Watson Alley in Eagle Park Acres (shown on Figure 2 and the photographs in Attachment 2) was inspected and noted to be in good condition.

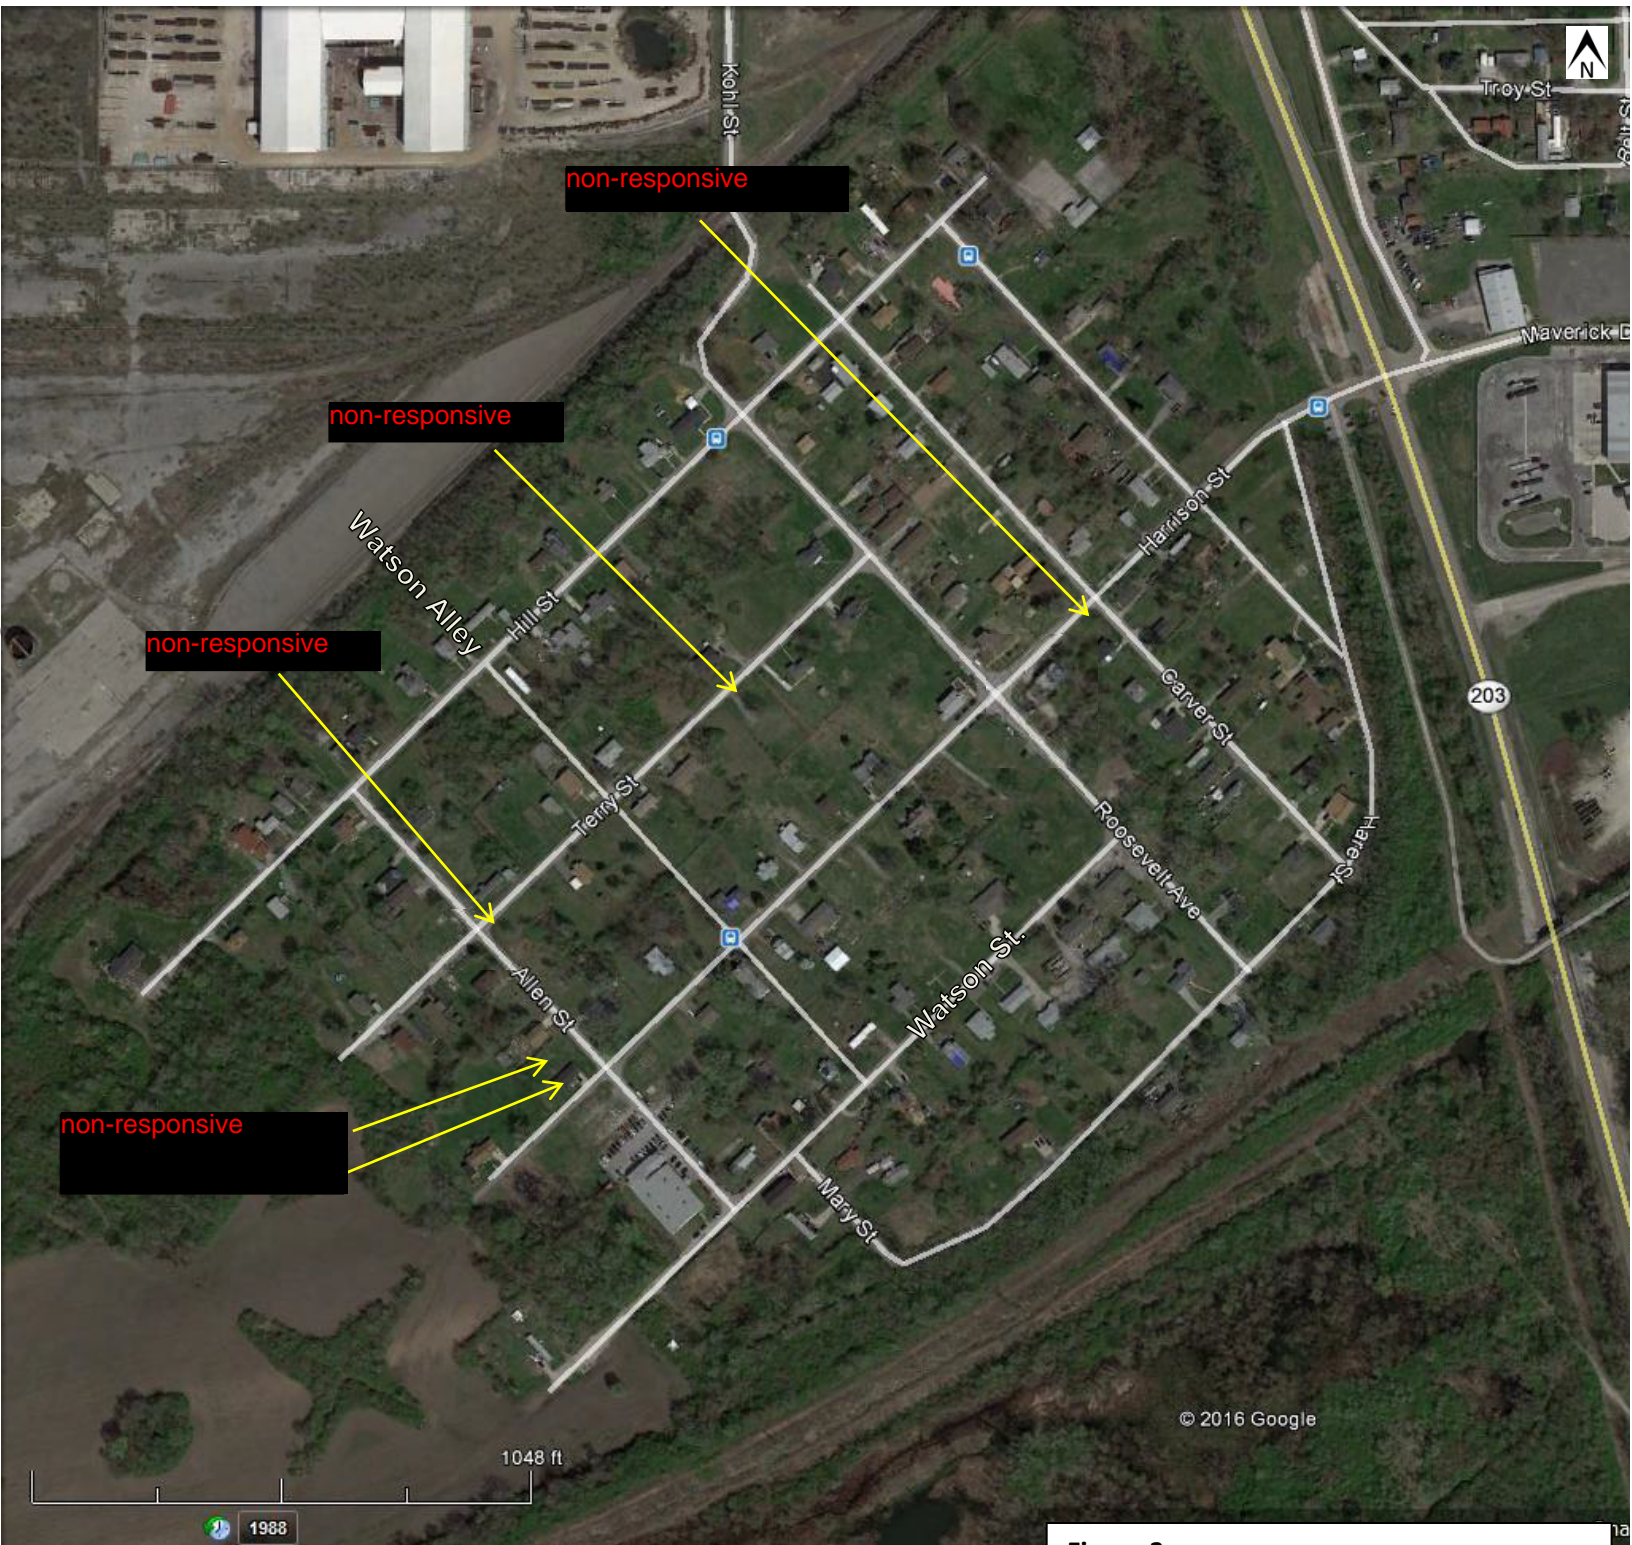
Figure 3
Eagle Park Acres - Remote Fill Properties
 (non-responsive [redacted])
 (non-responsive [redacted]) /
 (non-responsive [redacted])

- Four remote fill properties (non-responsive [REDACTED]) (now known as non-responsive [REDACTED]), and non-responsive [REDACTED] in Eagle Park Acres (Figure 3) that were previously remediated by EPA (and where lead-impacted soil and/or battery case chips may remain in place at a depth of three feet below the ground surface) were observed during the inspection. As shown on the photographs in Attachment 3, the properties are vacant (except for a house on non-[REDACTED]) and no evidence of subsurface soil disturbance was observed. As you know, the Group submitted a memorandum to EPA on August 7, 2017 requesting that EPA confirm that operation and maintenance requirements and institutional controls requirements are not applicable, or can be waived, for these properties.

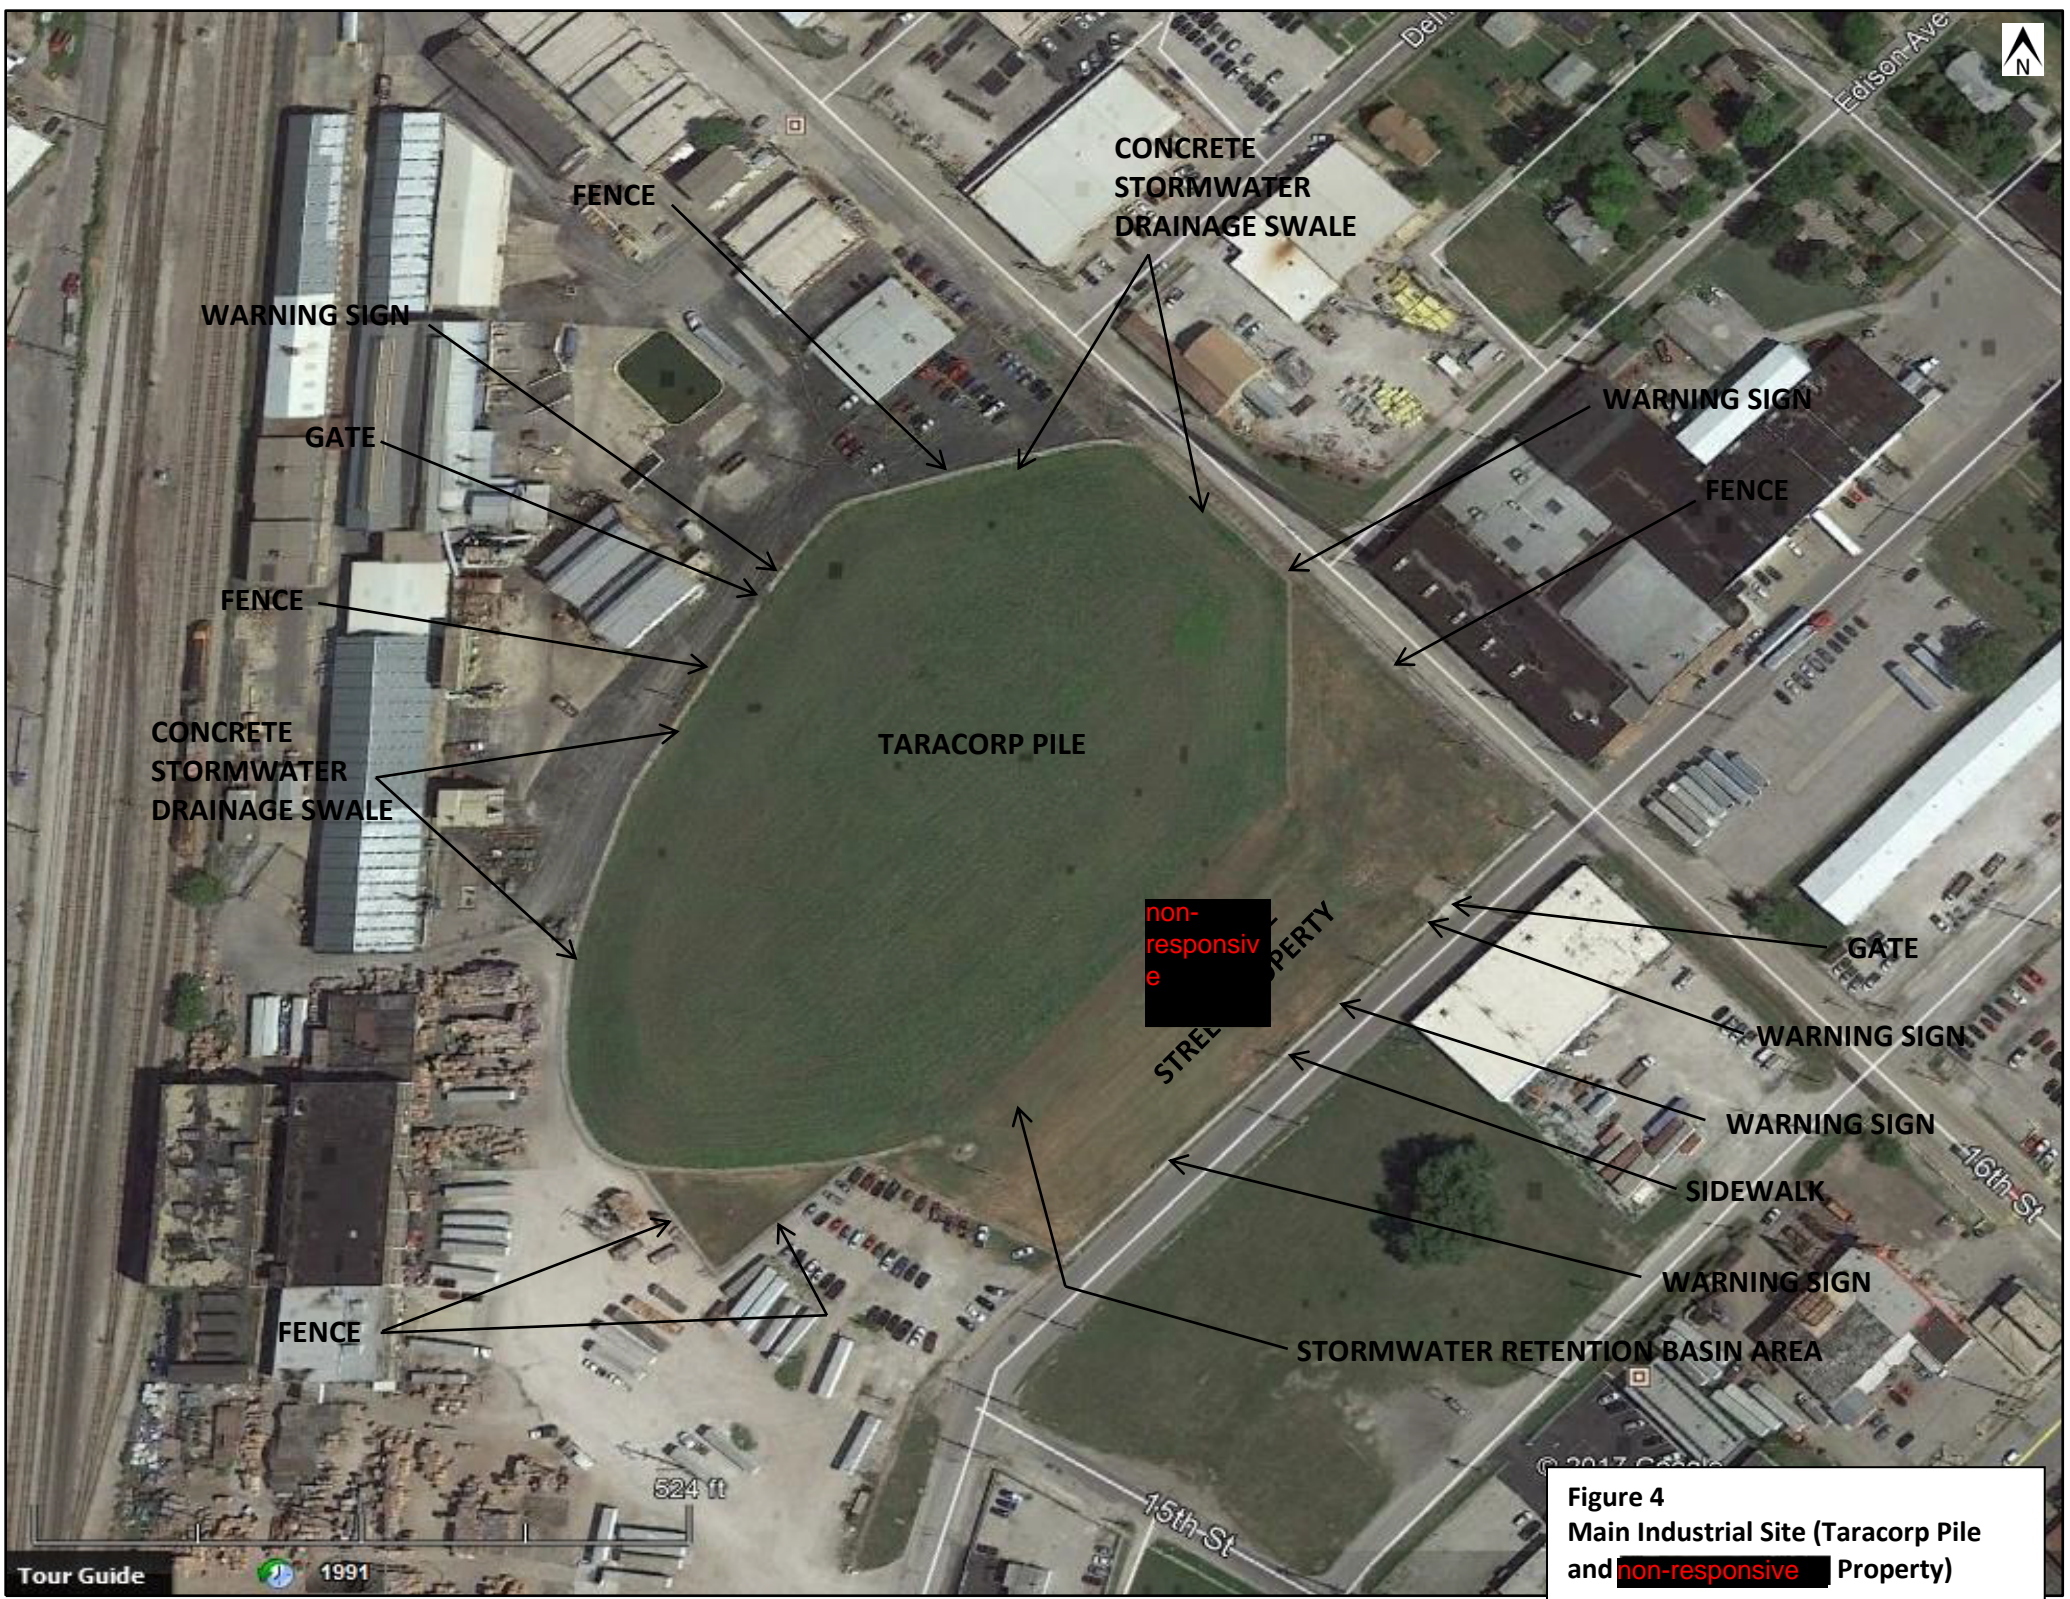
Figure 4
Main Industrial Site (Taracorp Pile
and non-responsive Property)

- Observations at the Taracorp pile cap and **non-responsive** property (Figure 4) are shown on the photographs provided in Attachment 5. As previously reported, All Pallet Service, Inc., the operator of the pallet recycling company on the **non-responsive** properties (e.g., the State Street Warehouse properties), was notified following the May 2017 inspection of the need to exercise care in its pallet storage/handling activities and to repair the fence in those areas. Since the time of the May 2017 inspection, All Pallet Service, Inc. has repaired the fence (Attachment 5, photographs 27-37), and the fence remains slightly bent in one area (Appendix 5, photographs 34 and 35). No problems related to the Taracorp pile cap, the concrete surface water drainage channel around the Taracorp pile, or warning signs on the fence were observed during the inspection.

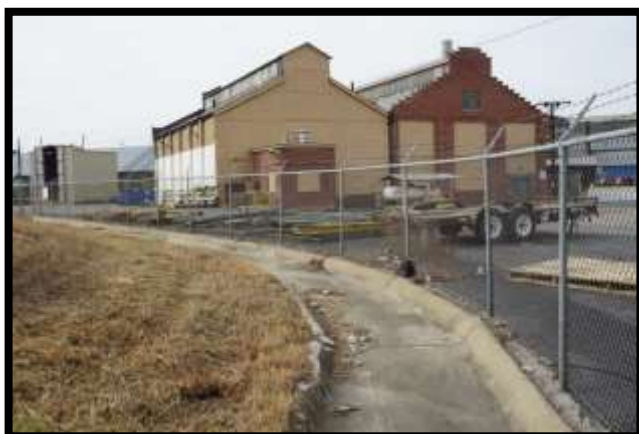
Evidence of cracks or other deterioration	Yes	Yes	Some cracks observed in concrete drainage channel (probably from mowing). No evidence of adverse impacts to surface water drainage.	
Evidence of obstructions	Yes	No		
Evidence of erosion	Yes	No		
Evidence of improper drainage	Yes	No		
Comments				
Retention Basin for Stormwater Runoff				
Adequate vegetation	Yes	No		
Evidence of erosion or deterioration	Yes	No		
Appropriate drainage to storm sewer	Yes	No		
Comments			No problems with retention basin evident.	
Concrete Sidewalk non-responsive Property)				
Evidence of cracks or other deterioration	Yes	No		
Comments			Concrete sidewalk is in good condition; no problems identified.

Photograph 17: Concrete drainage swale, crack in concrete along northwestern side of Taracorp pile.

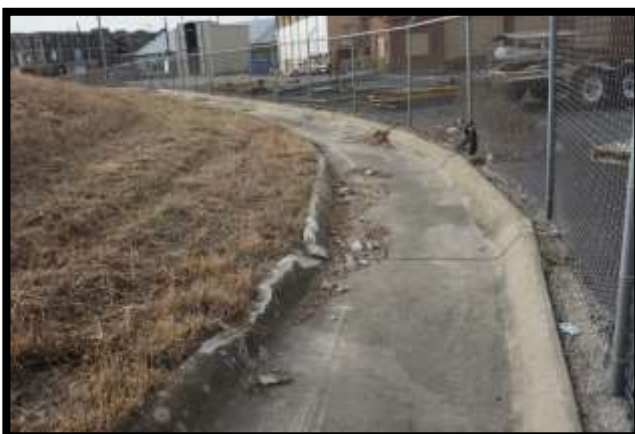
Photograph 18: Concrete drainage swale, crack in concrete along northwestern side of Taracorp pile.

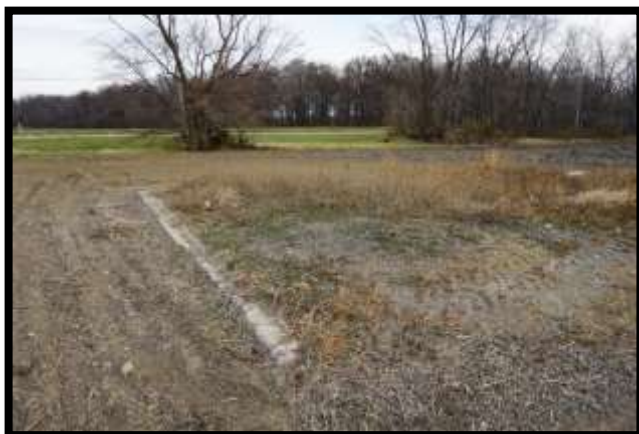
Photograph 3: Sand Road property, concrete foundation.

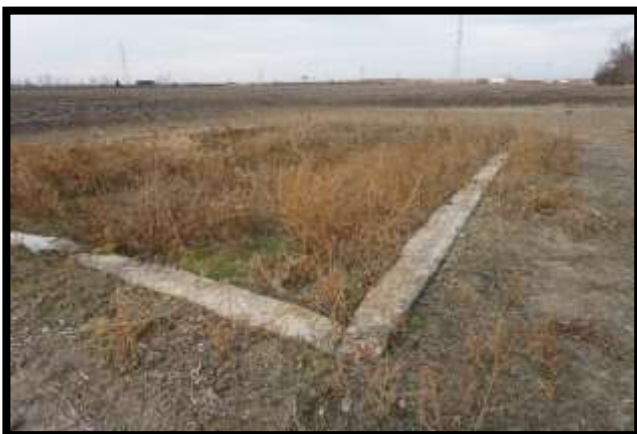
Photograph 4: Sand Road property, concrete foundation.

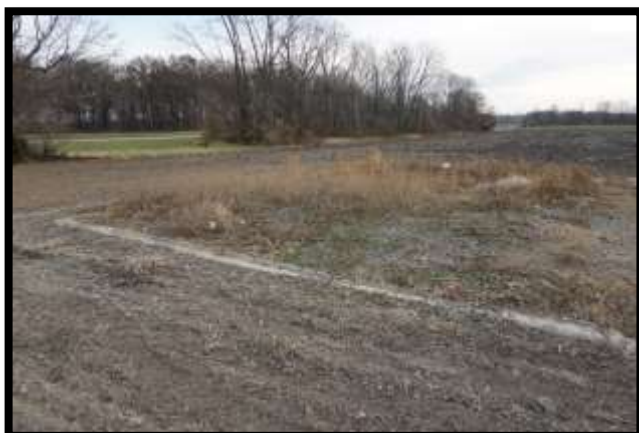
Photograph 5: Sand Road property, concrete foundation.

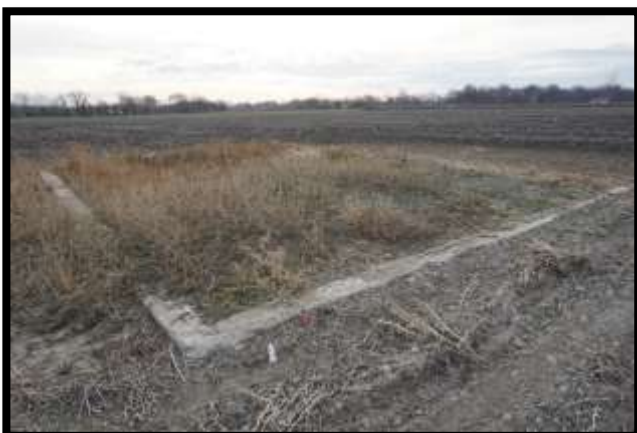
Photograph 6: Sand Road property, concrete foundation.

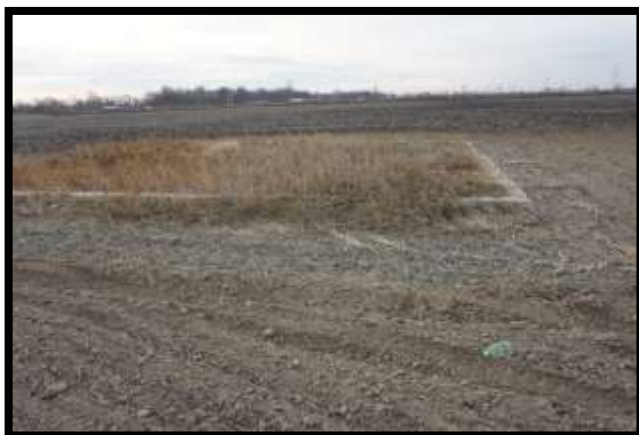
Photograph 7: Sand Road property, concrete foundation.

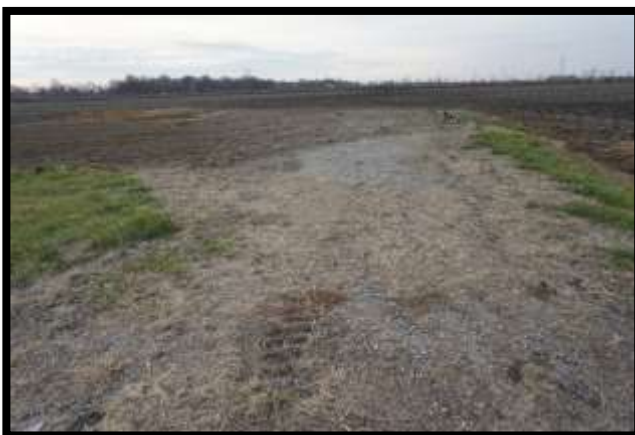
Photograph 8: Sand Road property, access road.
